RE: Fairbury Asbestos Inspection Report  
Property of Michael Soalfeld  
210 W 3<sup>rd</sup> Street  
Fairbury, NE 68352  
40.133920° N, 97.188167° W

## Building Asbestos Inspection Report

Inspection Date: 2/10/2023

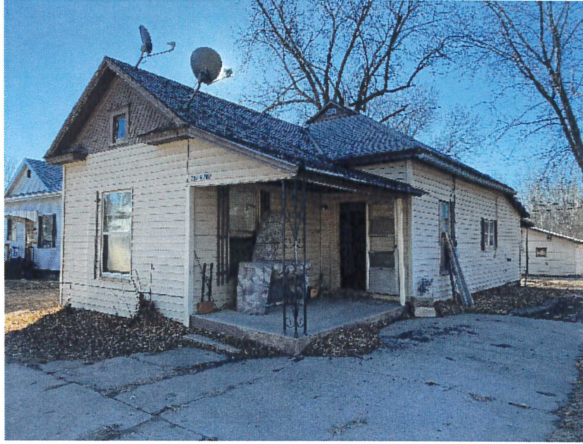
Northwest exterior elevation  
viewing southeast

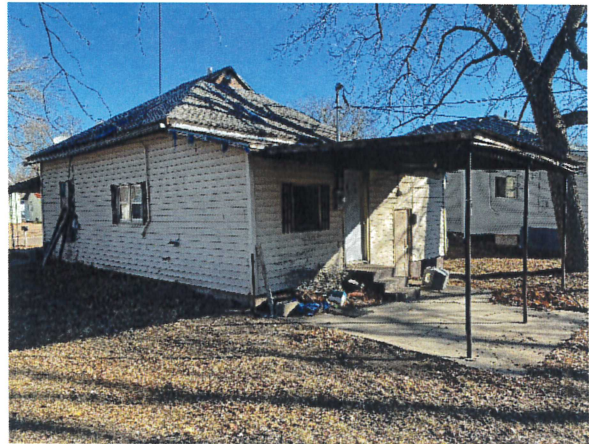
Southwest exterior elevation  
viewing northeast

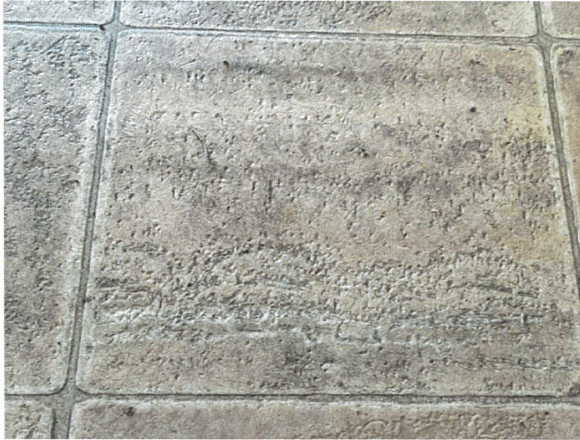
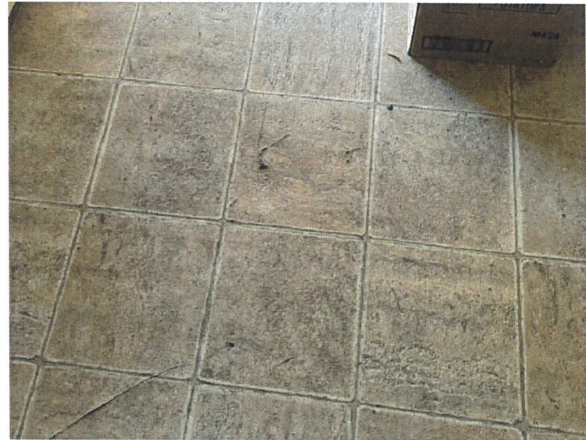
| Sample Date | Sample ID | Description | Location | Asbestos Result <sup>2</sup> | Asbestos Type | ACM Category | Friable Y/N | Quantity |
|---|---|---|---|---|---|---|---|---|
| 2/10/2023 | FAI-121-100223-001, 002, 003 | Brown Vinyl Sheet Flooring | Interior, Living Room, Mudroom, and Bathroom | None Detected | N/A | N/A | N | 280 sf |

FAI-121-100223-001, 002, 003  
None Detected, Brown Vinyl Sheet  
Flooring

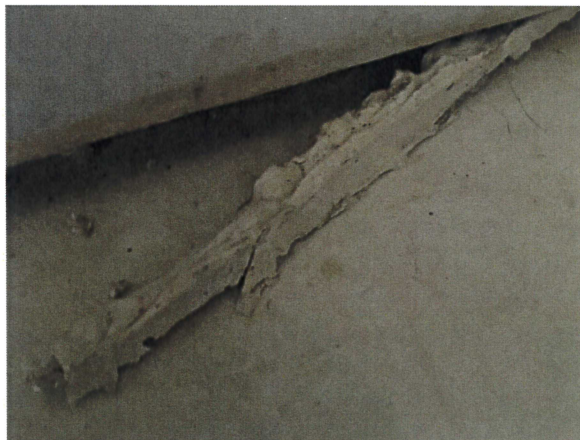
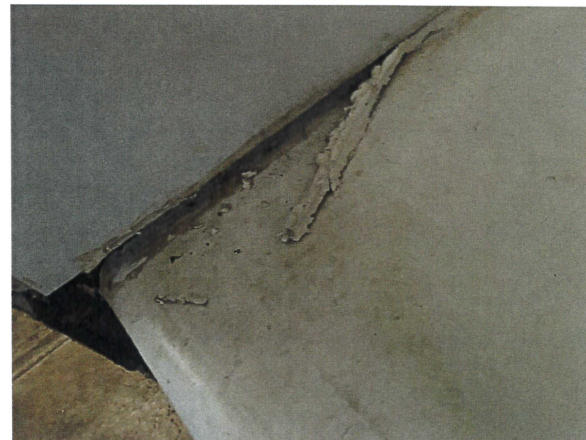
| Sample Date | Sample ID | Description | Location | Asbestos Result <sup>2</sup> | Asbestos Type | ACM Category | Friable Y/N | Quantity |
|---|---|---|---|---|---|---|---|---|
| 2/10/2023 | FAI-121-100223-004, 005, 006 | White Sealant | Interior, Bathroom: tub seams | None Detected | N/A | N/A | N | 2 sf |

FAI-121-100223-004, 005, 006  
None Detected, White Sealant

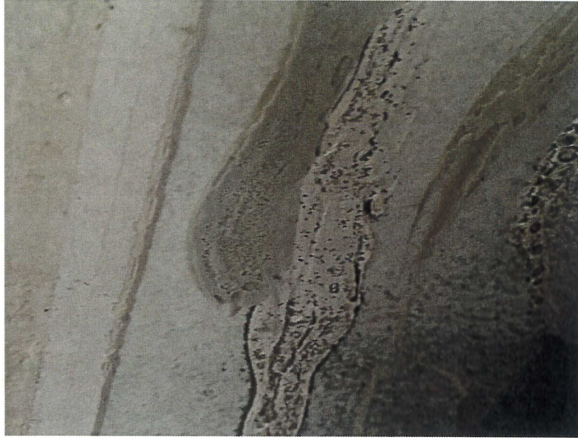
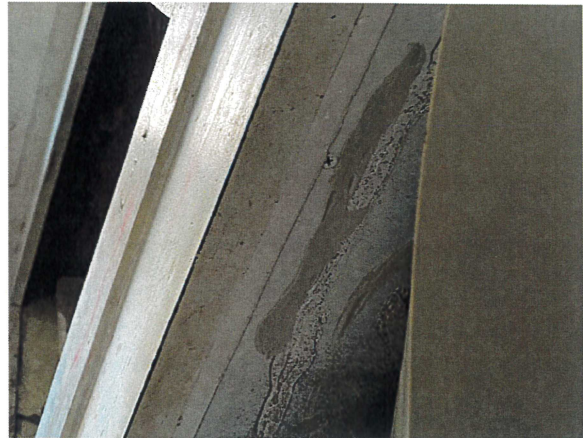
| Sample Date | Sample ID | Description | Location | Asbestos Result <sup>2</sup> | Asbestos Type | ACM Category | Friable Y/N | Quantity |
|---|---|---|---|---|---|---|---|---|
| 2/10/2023 | FAI-121-100223-007, 008, 009 | White Panel Glue | Interior, Bathroom: behind shower walls | None Detected | N/A | N/A | N | 3 sf |

FAI-121-100223-007, 008, 009  
None Detected, White Panel Glue

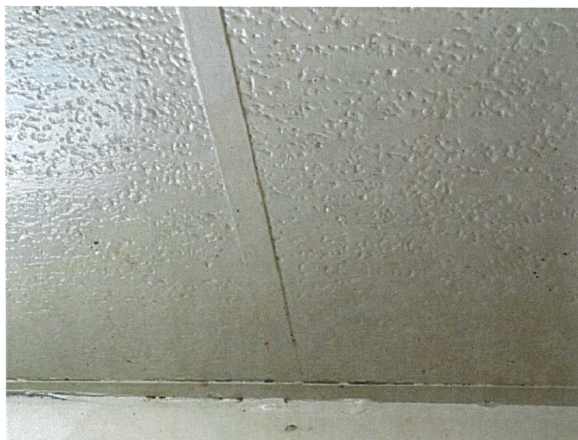
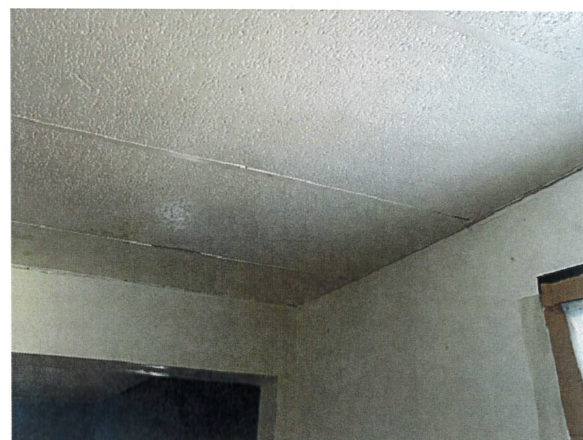
| Sample Date | Sample ID | Description | Location | Asbestos Result <sup>2</sup> | Asbestos Type | ACM Category | Friable Y/N | Quantity |
|---|---|---|---|---|---|---|---|---|
| 2/10/2023 | FAI-121-100223-010, 011, 012 | 2' x 4' White Ceiling Tile | Interior, Living Room, Kitchen, Bedrooms 1, 2, & 3 ceilings | None Detected | N/A | N/A | N | 745 sf |

FAI-121-100223-010, 011, 012  
None Detected, 2' x 4' White  
Ceiling Tile

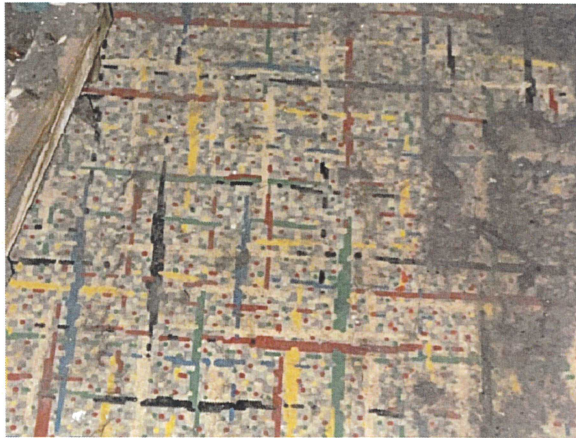
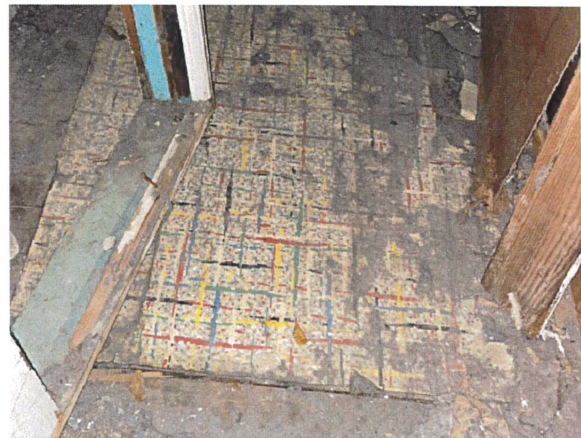
| Sample Date | Sample ID | Description | Location | Asbestos Result <sup>2</sup> | Asbestos Type | ACM Category | Friable Y/N | Quantity |
|---|---|---|---|---|---|---|---|---|
| 2/10/2023 | FAI-121-100223-013, 014, 015 | Multi-colored Vinyl Sheet Flooring | Interior, Closet 2 | None Detected | N/A | N/A | N | 40 sf |

FAI-121-100223-013, 014, 015  
None Detected, Multi-colored  
Vinyl Sheet Flooring

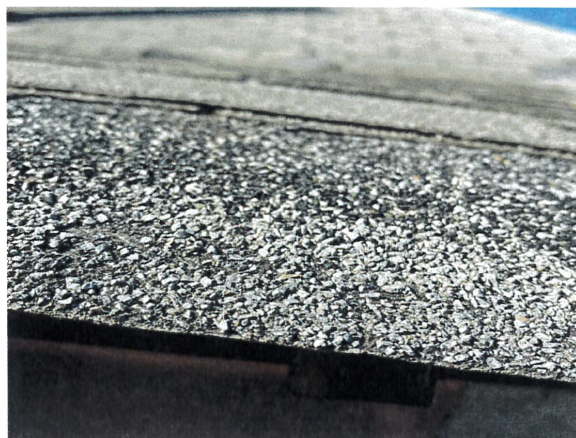
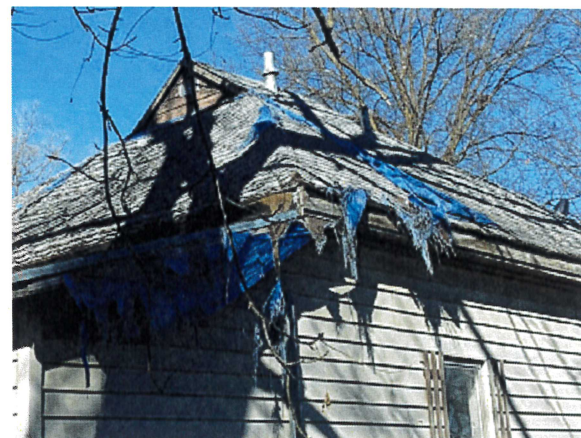
| Sample Date | Sample ID | Description | Location | Asbestos Result <sup>2</sup> | Asbestos Type | ACM Category | Friable Y/N | Quantity |
|---|---|---|---|---|---|---|---|---|
| 2/10/2023 | FAI-121-100223-016, 017, 018, 019, 020 | Gray Shingles | Exterior, Roof | None Detected | N/A | N/A | N | 1,250 sf |

FAI-121-100223-016, 017, 018,  
019, 020 None Detected, Gray  
Shingles
