RE: Fairbury Asbestos Inspection Report  
Property of Marci & Norbert Kowalski  
322 W 3<sup>rd</sup> Street  
Fairbury, NE 68352  
40.133878° N, 97.189582° W

## Building Asbestos Inspection Report

Inspection Date: 2/13/2023

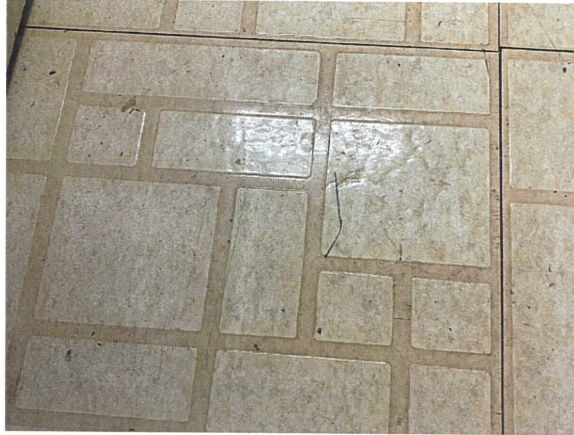
FAI-322-130223-001, 002, 003  
None Detected, 12" x 12" Tan  
Vinyl Floor Tile

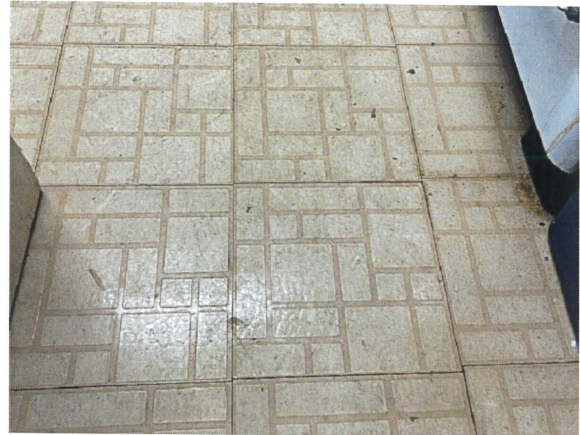
FAI-322-130223-001, 002, 003  
None Detected, 12" x 12" Tan  
Vinyl Floor Tile

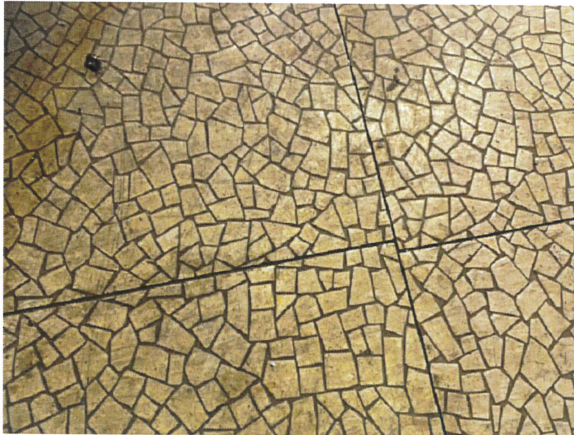
| Sample Date | Sample ID | Description | Location | Asbestos Result <sup>2</sup> | Asbestos Type | ACM Category | Friable Y/N | Quantity |
|---|---|---|---|---|---|---|---|---|
| 2/13/2023 | FAI-322-130223-004, 005, 006 | 12" x 12" Brown Vinyl Floor Tile / Black Mastic | Interior, Dining Room | 2% / 2% | Chrysotile/Chrysotile | Cat 1 / Cat 2 | N | 272 sf |

FAI-322-130223-004, 005, 006 **2%**  
**/ 2%**, 12" x 12" Brown Vinyl Floor  
Tile / Black Mastic

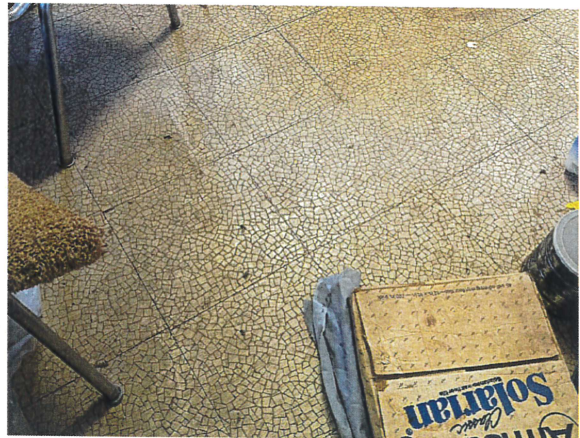
FAI-322-130223-004, 005, 006 **2%**  
**/ 2%**, 12" x 12" Brown Vinyl Floor  
Tile / Black Mastic

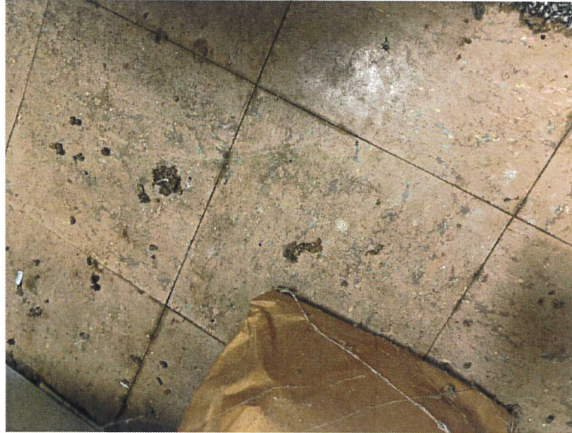
| Sample Date | Sample ID | Description | Location | Asbestos Result <sup>2</sup> | Asbestos Type | ACM Category | Friable Y/N | Quantity |
|---|---|---|---|---|---|---|---|---|
| 2/13/2023 | FAI-322-130223-007, 008, 009 | 9" x 9" Brown Vinyl Floor Tile | Interior, Bathroom | 2% | Chrysotile | Cat 1 | N | 48 sf |

FAI-322-130223-007, 008, 009 **2%**,  
9" x 9" Brown Vinyl Floor Tile

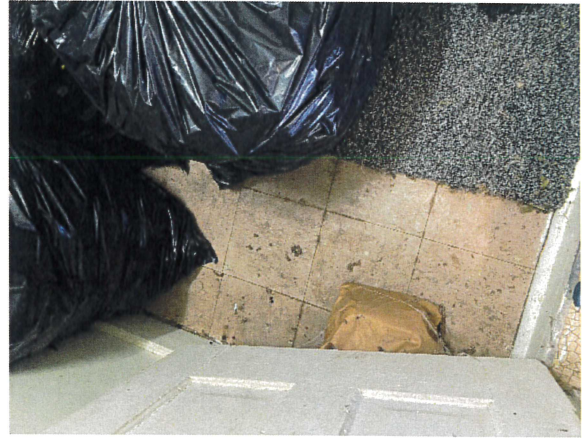
FAI-322-130223-007, 008, 009 **2%**,  
9" x 9" Brown Vinyl Floor Tile

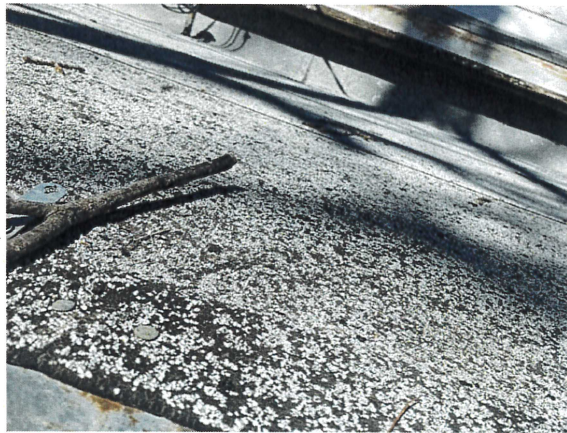
FAI-322-130223-010, 011, 012,  
013, 014 None Detected, Green  
and White Shingle

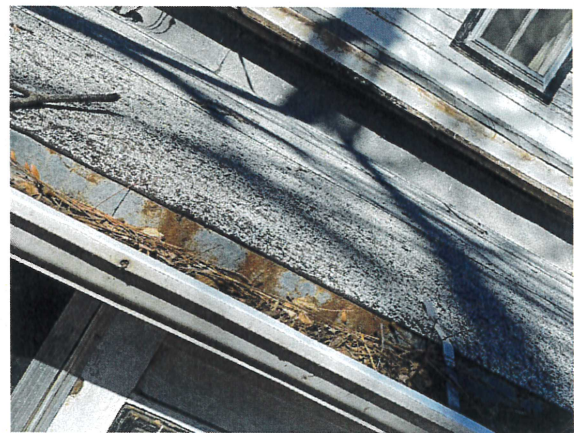
FAI-322-130223-010, 011, 012,  
013, 014 None Detected, Green  
and White Shingle
