RE: Fairbury Asbestos Inspection Report  
Property of Teresa Smith  
310 W 3<sup>rd</sup> Street  
Fairbury, NE 68352  
40.133856° N, 97.189080° W

## Building Asbestos Inspection Report

Inspection Date: 2/09/2023

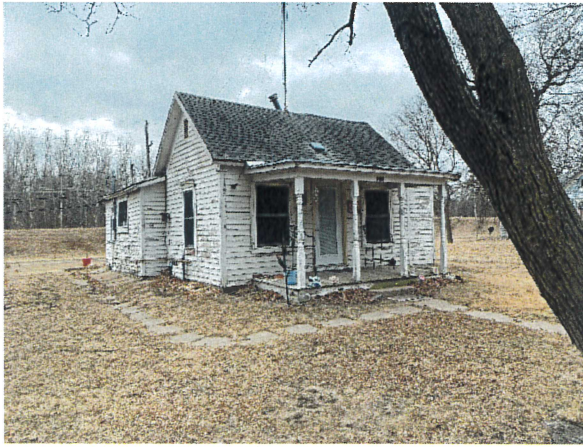
Northeast exterior elevation  
viewing southwest

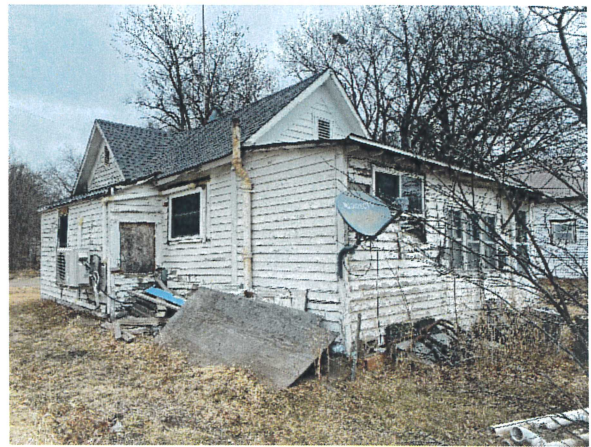
Southwest exterior elevation  
viewing northeast

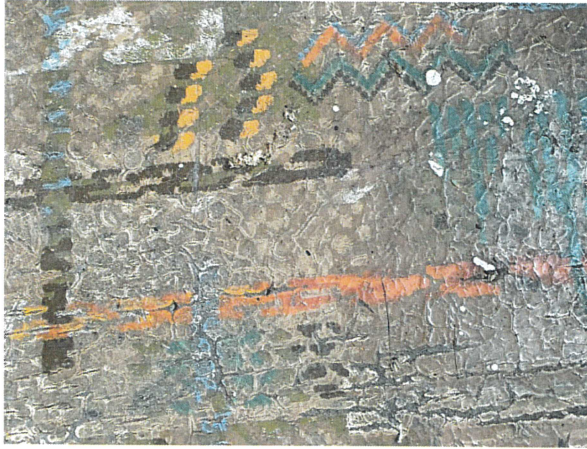
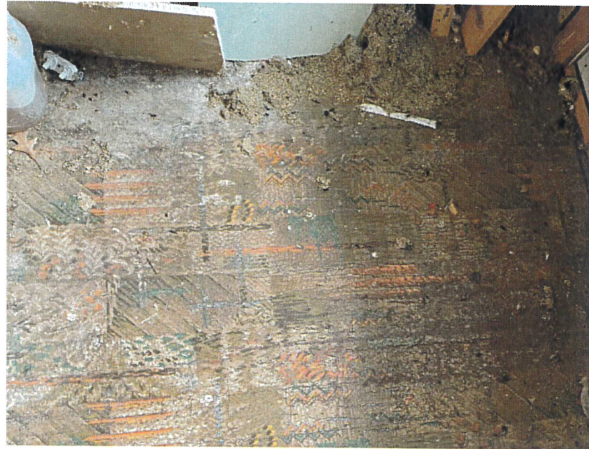
| Sample Date | Sample ID | Description | Location | Asbestos Result <sup>2</sup> | Asbestos Type | ACM Category | Friable Y/N | Quantity |
|---|---|---|---|---|---|---|---|---|
| 2/09/2023 | FAI-310-090223-001, 002, 003 | Multi-colored Vinyl Sheet Flooring | Interior, Foyer | None Detected | N/A | N/A | N | 84 sf |

FAI-310-090223-001, 002, 003  
None Detected, Multi-colored  
Vinyl Sheet Flooring

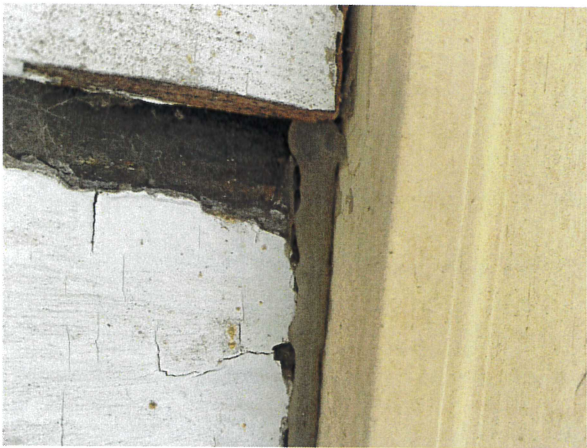
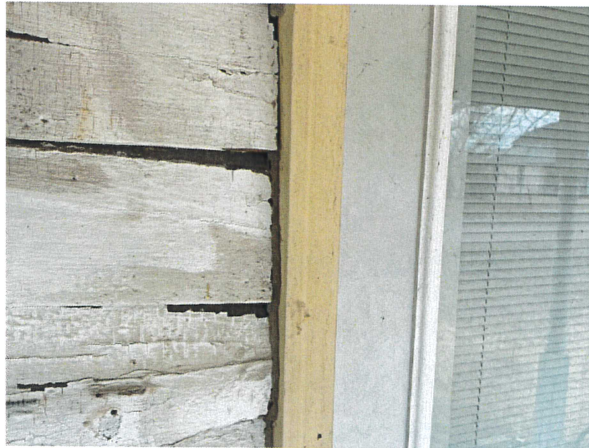
| Sample Date | Sample ID | Description | Location | Asbestos Result <sup>2</sup> | Asbestos Type | ACM Category | Friable Y/N | Quantity |
|---|---|---|---|---|---|---|---|---|
| 2/09/2023 | FAI-310-090223-004, 005, 006 | Clear Caulk | Exterior, Front door seams | None Detected | N/A | N/A | N | 2 sf |

FAI-310-090223-004, 005, 006  
None Detected, Clear Caulk

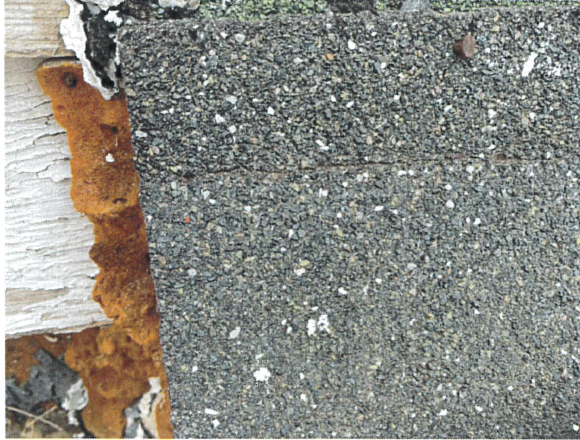
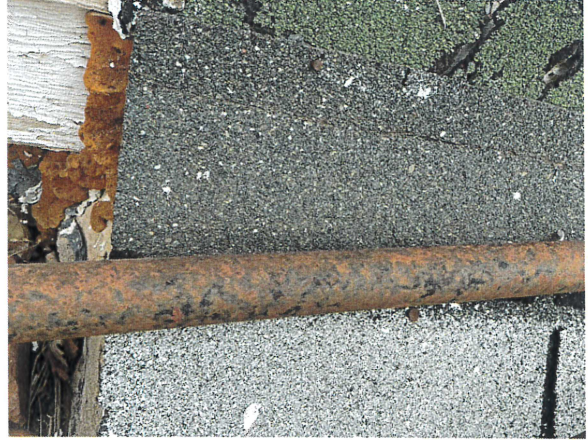
| Sample Date | Sample ID | Description | Location | Asbestos Result <sup>2</sup> | Asbestos Type | ACM Category | Friable Y/N | Quantity |
|---|---|---|---|---|---|---|---|---|
| 2/09/2023 | FAI-310-090223-007, 008, 009 | Gray Shingles | Exterior, Roof (top layer) | None Detected | N/A | N/A | N | 750 sf |

FAI-310-090223-007, 008, 009  
None Detected, Gray Shingles

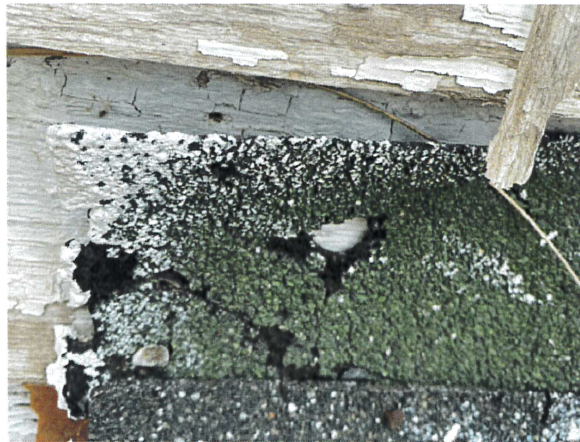
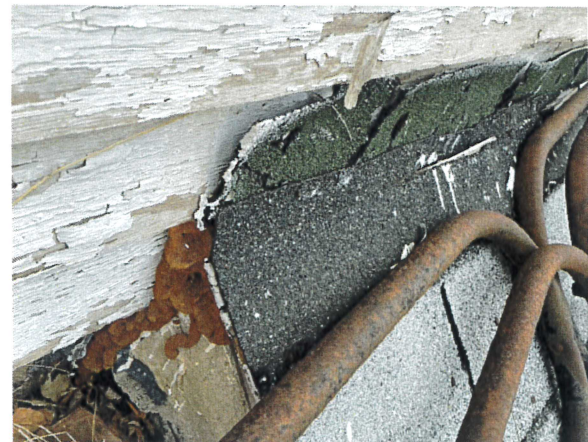
| Sample Date | Sample ID | Description | Location | Asbestos Result <sup>2</sup> | Asbestos Type | ACM Category | Friable Y/N | Quantity |
|---|---|---|---|---|---|---|---|---|
| 2/09/2023 | FAI-310-090223-010, 011, 012 | Green Shingles | Exterior, Roof (bottom layer) | None Detected | N/A | N/A | N | 750 sf |

FAI-310-090223-010, 011, 012  
None Detected, Green Shingles

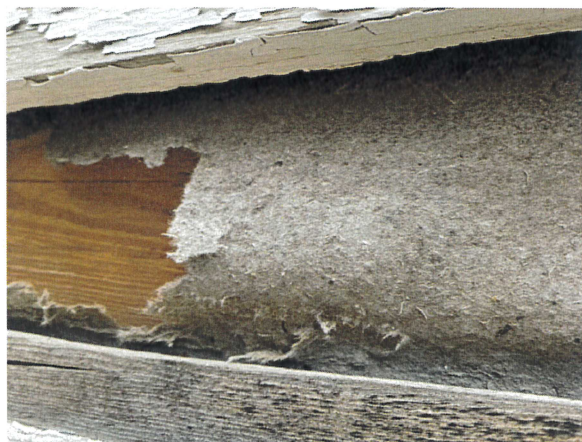
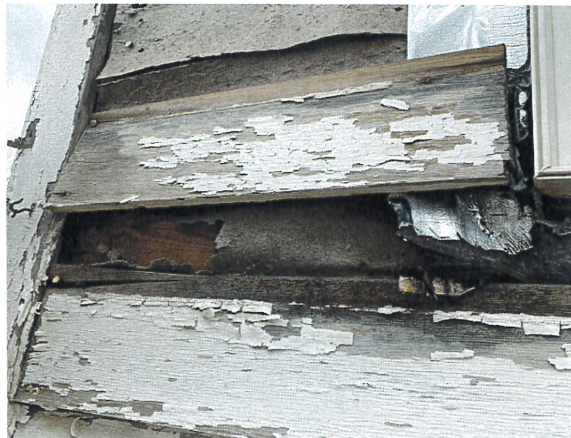
| Sample Date | Sample ID | Description | Location | Asbestos Result <sup>2</sup> | Asbestos Type | ACM Category | Friable Y/N | Quantity |
|---|---|---|---|---|---|---|---|---|
| 2/09/2023 | FAI-310-090223-013, 014, 015, 016, 017 | Gray Felt Paper | Exterior, Roof under shingles and Walls behind siding | None Detected | N/A | N/A | N | 1,692 sf |

FAI-310-090223-013, 014, 015  
None Detected, Gray Felt Paper
