RE: Fairbury Asbestos Inspection Report  
Property of Teresa Smith  
310 W 3<sup>rd</sup> Street  
Fairbury, NE 68352  
40.133856° N, 97.189080° W

## Building Asbestos Inspection Report

Inspection Date: 2/09/2023

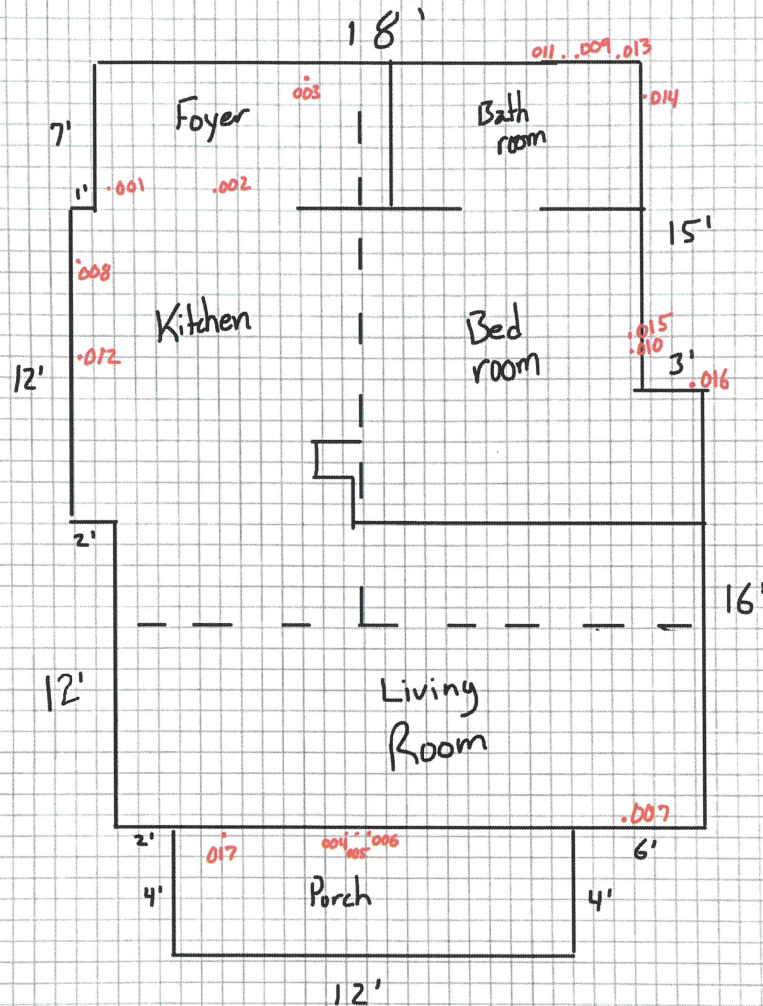
### Sample Locations

| Sample Date | Sample ID | Description | Location | Asbestos Result <sup>2</sup> | Asbestos Type | ACM Category | Friable Y/N | Quantity |
|---|---|---|---|---|---|---|---|---|
| 2/09/2023 | FAI-310-090223-001, 002, 003 | Multi-colored Vinyl Sheet Flooring | Interior, Foyer | None Detected | N/A | N/A | N | 84 sf |
| 2/09/2023 | FAI-310-090223-004, 005, 006 | Clear Caulk | Exterior, Front door seams | None Detected | N/A | N/A | N | 2 sf |
| 2/09/2023 | FAI-310-090223-007, 008, 009 | Gray Shingles | Exterior, Roof (top layer) | None Detected | N/A | N/A | N | 750 sf |
| 2/09/2023 | FAI-310-090223-010, 011, 012 | Green Shingles | Exterior, Roof (bottom layer) | None Detected | N/A | N/A | N | 750 sf |
| 2/09/2023 | FAI-310-090223-013, 014, 015, 016, 017 | Gray Felt Paper | Exterior, Roof under shingles and Walls behind siding | None Detected | N/A | N/A | N | 1,692 sf |

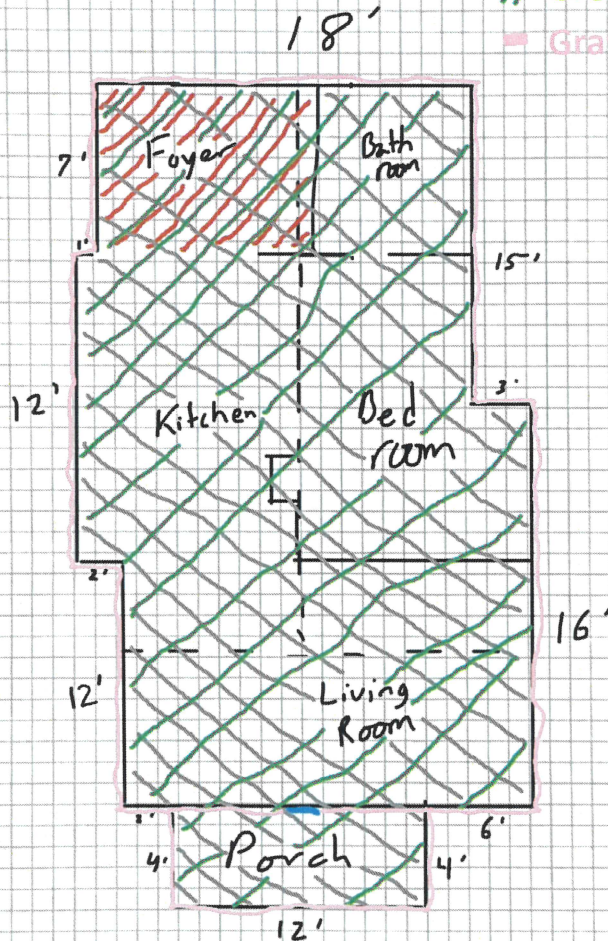
Gray Felt Paper

| ALSO UNDER ROOF | SCHEMATIC DRAWINGS | |
